NATIONAL TRANSPORTATION SAFETY BOARD

SPECIAL INVESTIGATION REPORT

**BRITTLE-LIKE CRACKING IN
PLASTIC PIPE FOR GAS SERVICE**

**Adopted: April 23, 1998
Notation 6984**

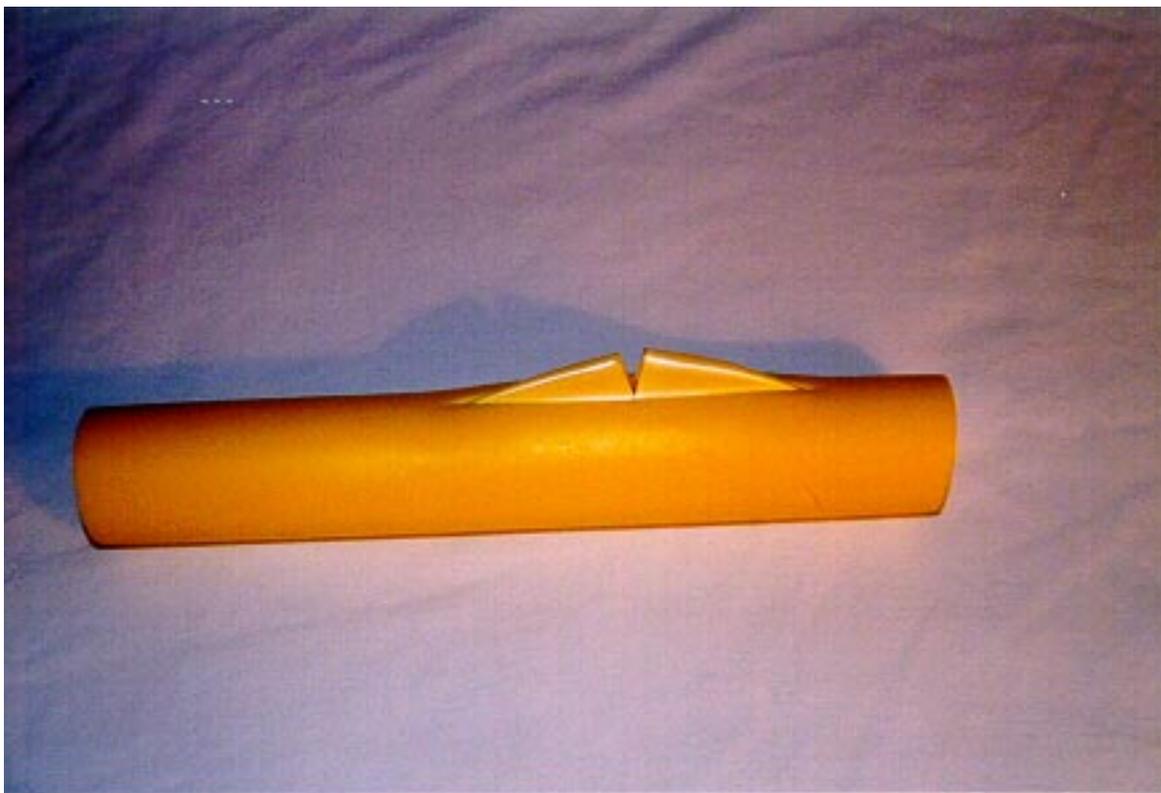
Figure 4 -- Ductile fracture resulting from stress rupture test. Note substantial deformation (ballooning) at the failure.

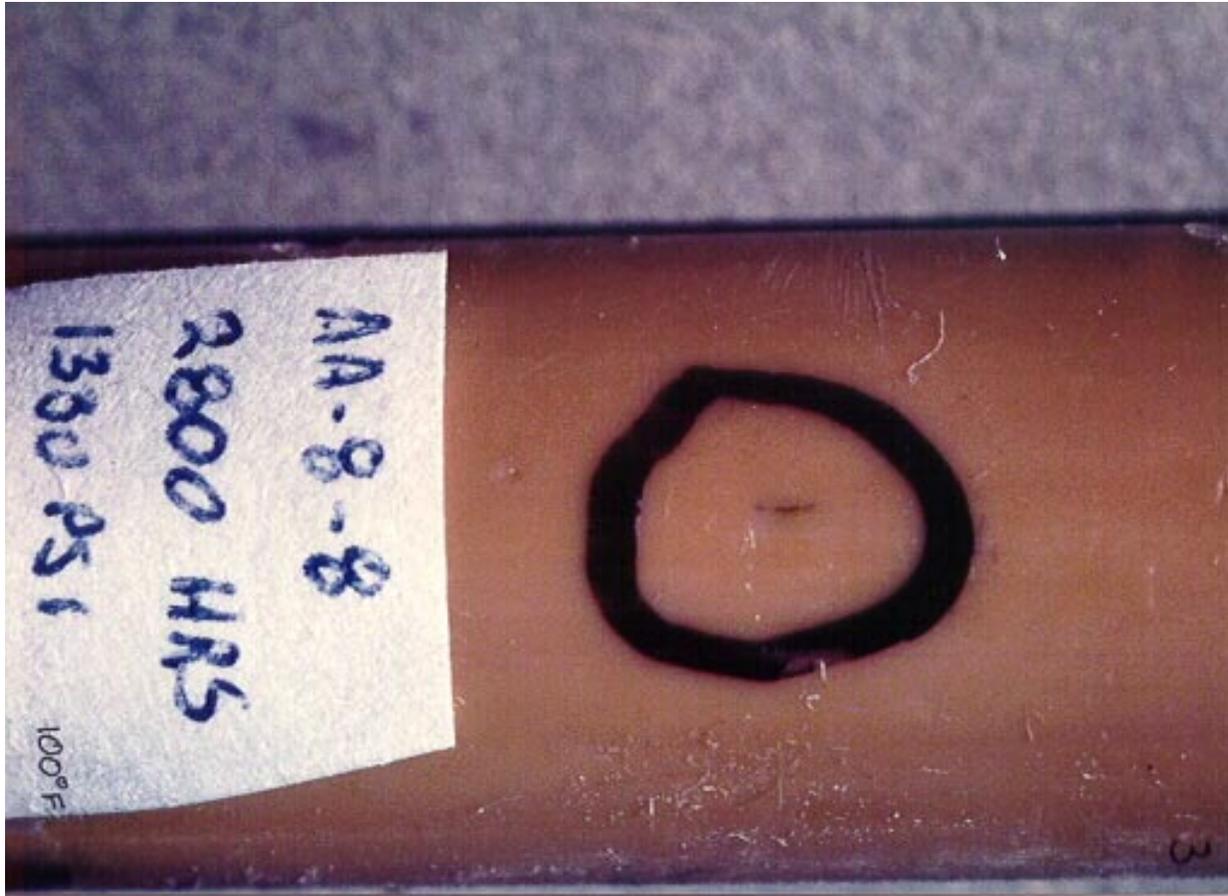
to appear at some point (depending on the specific polyethylene resin material). Figure 5 shows a slit fracture that resulted from a stress rupture test. The PPI procedure did not differentiate between ductile and slit failure types, and, based on most available laboratory test data (at 73 °F),²⁸ assumed that both types of

Figure 5 -- Slit fracture resulting from a stress rupture test conducted at 100 °F. Note lack of deformation visible in the fracture. This pipe was manufactured by DuPont in 1977. After failing Minnegasco's incoming inspection tests, the pipe was subjected to stress rupture testing. (Source: Henrich, R.C., and Funck, D.L., "Effects of ESCR Variation on Some Other Properties of Plastic Pipe." *Proceedings, Eighth Annual Plastic Fuel Gas Pipe Symposium, 1983.*)

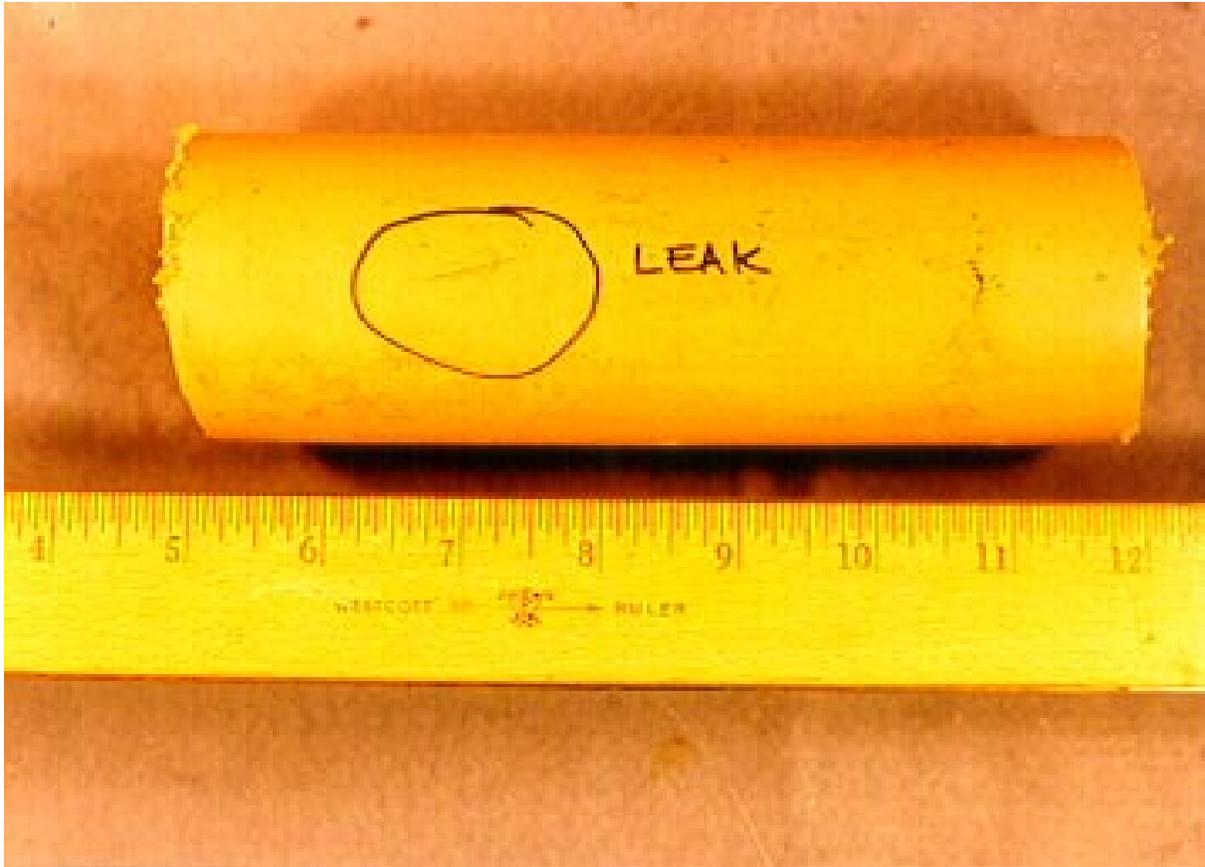
Figure 6 -- Slit fracture on a polyethylene pipe manufactured by DuPont that was found leaking and removed from a gas piping system.

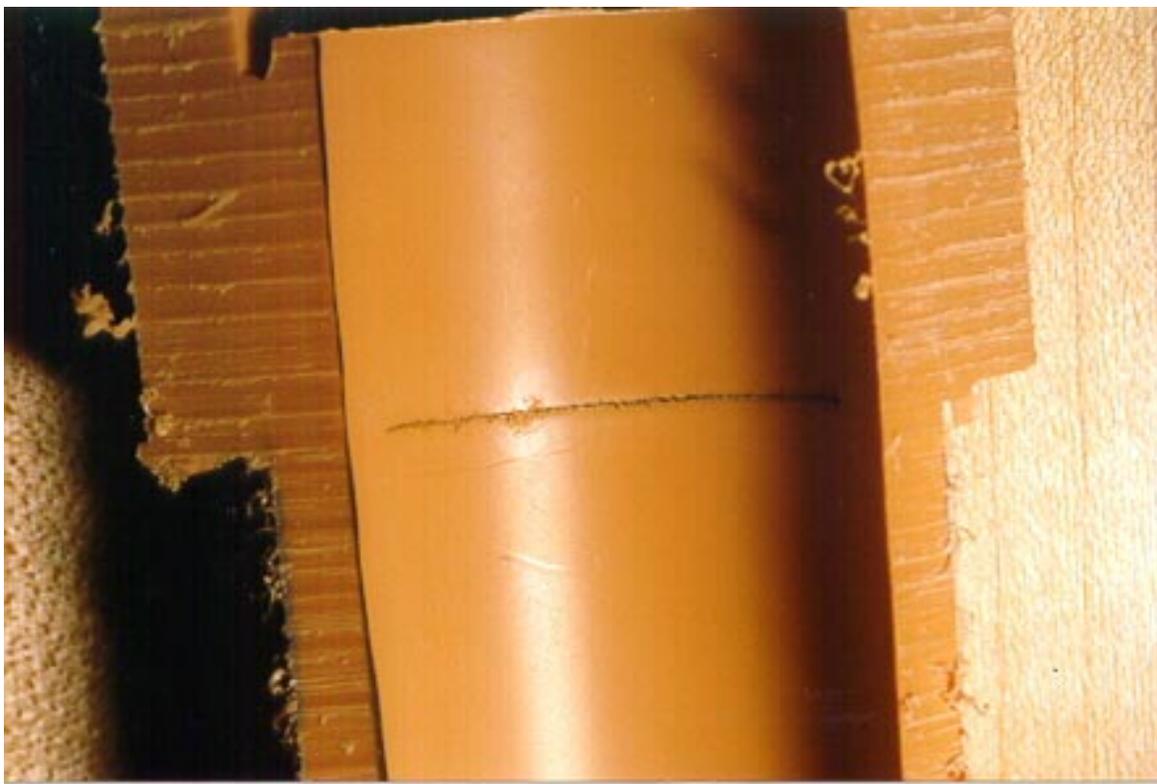
Figure 7 -- Interior of polyethylene pipe from San Juan pipeline accident showing brittle-like crack with no visible deformation.

Figure 7 illustrates brittle-like cracking that was found in a plastic pipe involved in the fatal propane gas explosion in San Juan, Puerto Rico, in November 1996. That pipe was manufactured in 1982 by E. I. du Pont de Nemours & Company, Inc., (DuPont) at its Pencador, Delaware, plant. Apparently, differential settlement resulting from inadequate support under the piping generated long-term stress intensification that led to the formation of brittle-like cracks in the pipe.

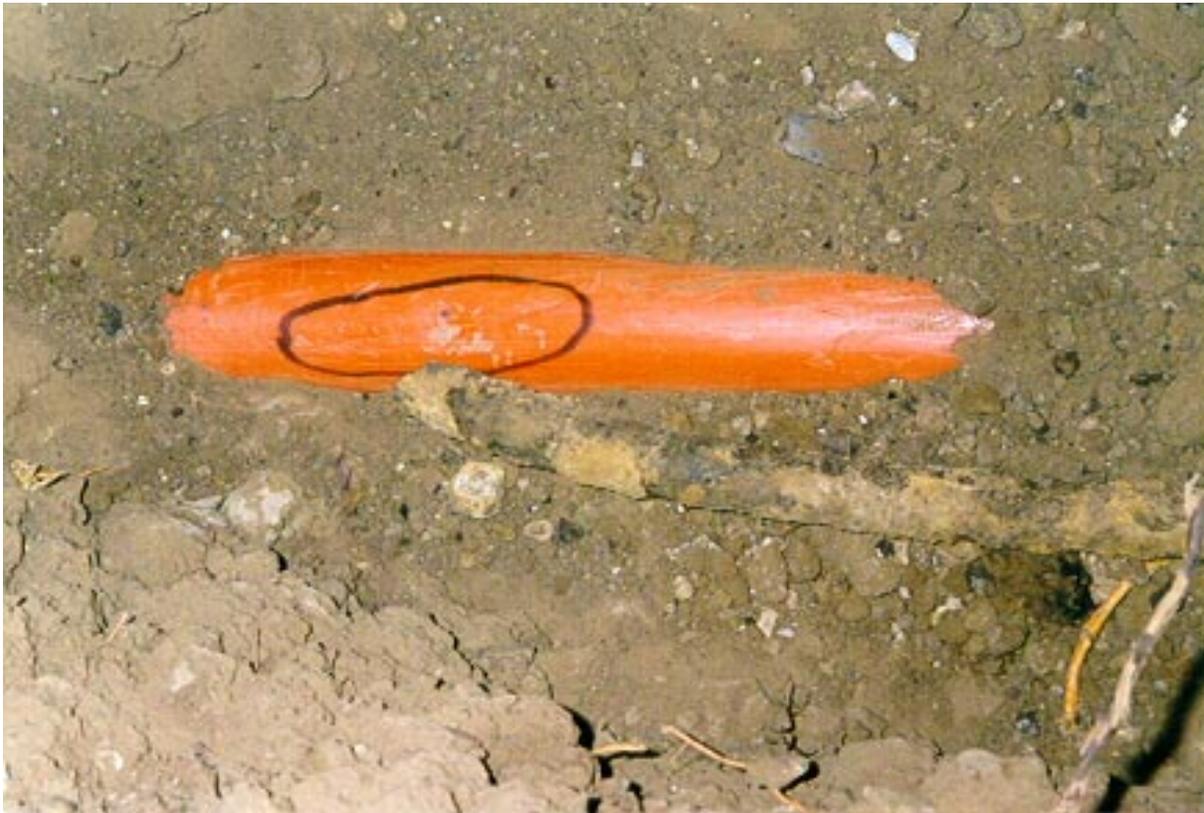
The Railroad Commission of Texas investigation of a fatal natural gas explosion and fire in Lake Dallas, Texas, in August 1997 determined that a metal pipe pressing against a plastic pipe generated stress intensification that led to a brittle-like crack in the plastic pipe.

Figure 8 -- Brittle-like crack in pipe involved in August 1997 accident in Lake Dallas, Texas. The crack extends from the left to upper right of the area defined by the ellipse.

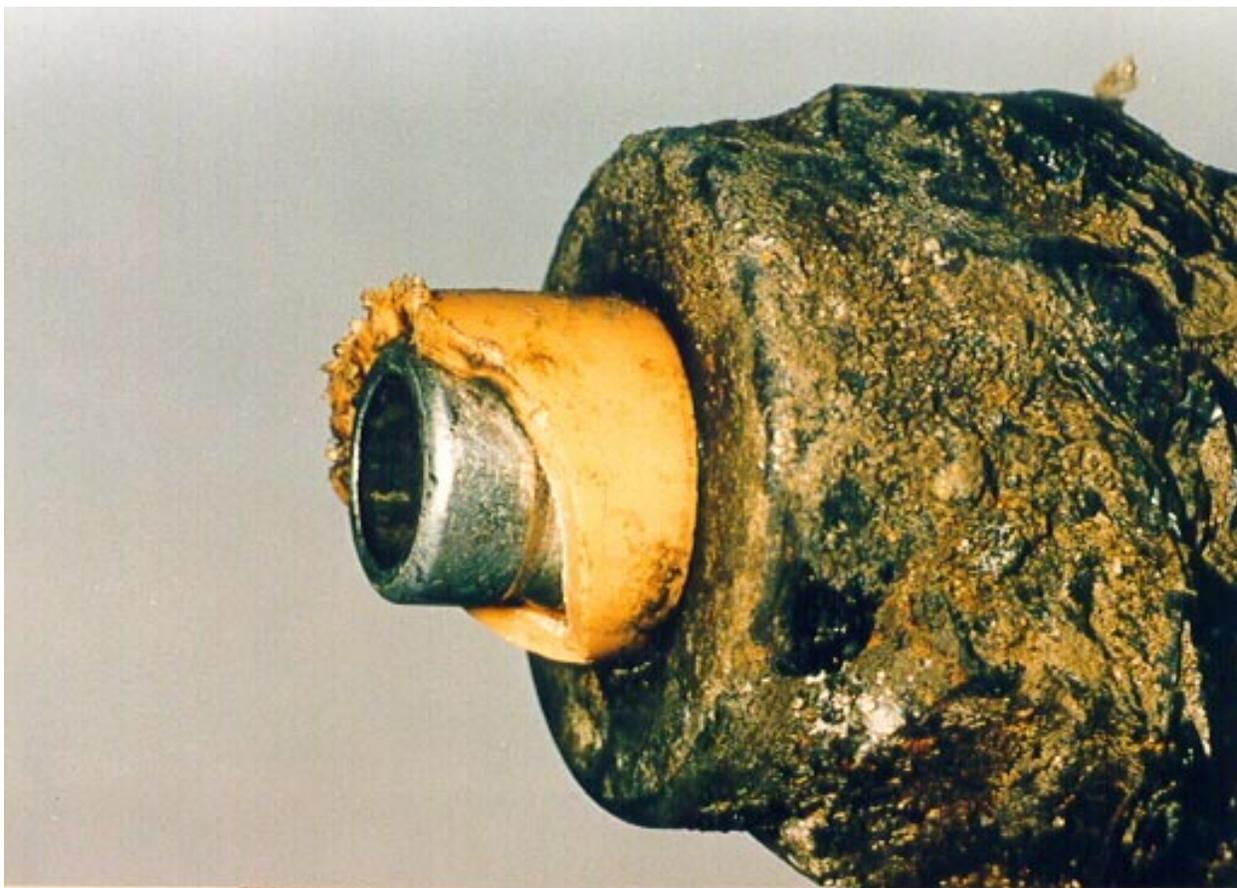
The investigation determined that much of the top portion of the circumference of the pipe immediately outside the tee's internal stiffener displayed several brittle-like slow crack initiation and growth fracture sites. These slow crack fractures propagated on almost parallel planes slightly offset from each other through the wall of the pipe. As the slow cracks from different planes continued to grow and began to overlap one another, ductile tearing occurred between the planes. Substantial deformation was observed in part of the fracture; however, the initiating cracks were still classified as brittle-like.

Figure 10 -- Close-up view of failed plastic pipe connection to steel tapping tee from site of Waterloo, Iowa, accident. A portion of the fractured plastic service line (light-colored material) remains attached to the tee.

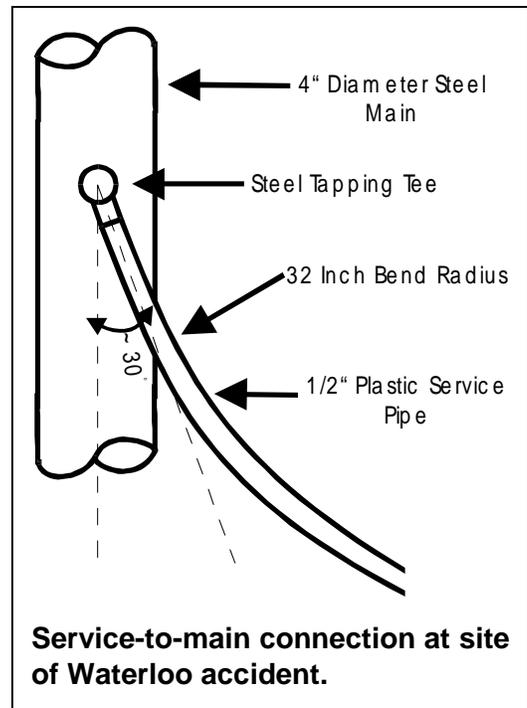
Service-to-main connection at site of Waterloo accident.

MidAmerican Energy estimated that the steel tee on the steel main was installed so that the polyethylene pipe exited the tee at an approximate 30° angle to the steel main. (See figure.)

The plastic service pipe leaving the tee immediately curved horizontally. After a portion of the pipe was taken to the laboratory for testing, the bend radius was measured at about 34 inches. Based on field conditions and photos, MidAmerican Energy has estimated the original installed horizontal bend radius to be approximately 32 inches.³ This bend is sharper than currently recommended by industry guidelines for modern piping adjacent to fittings. However, a former Iowa Public Service Company employee stated that Iowa Public Service Company, in an effort to reduce the stress at the connection point, often attempted to install polyethylene services at an angle to the main to match the residual bend left after uncoiling the pipe.⁴ This former employee stated that no set time was prescribed to allow for complete relaxing of the pipe, but that the pipe would be placed in the ditch, and the crews would weld the tee at what they judged to be the appropriate angle, in consideration of the natural bend of the pipe.
