Pipeline Accident Report

**Natural Gas Pipeline Rupture and Fire  
Near Carlsbad, New Mexico  
August 19, 2000**

**NTSB/PAR-03/01  
PB2003-916501  
Notation 7310B  
Adopted February 11, 2003**

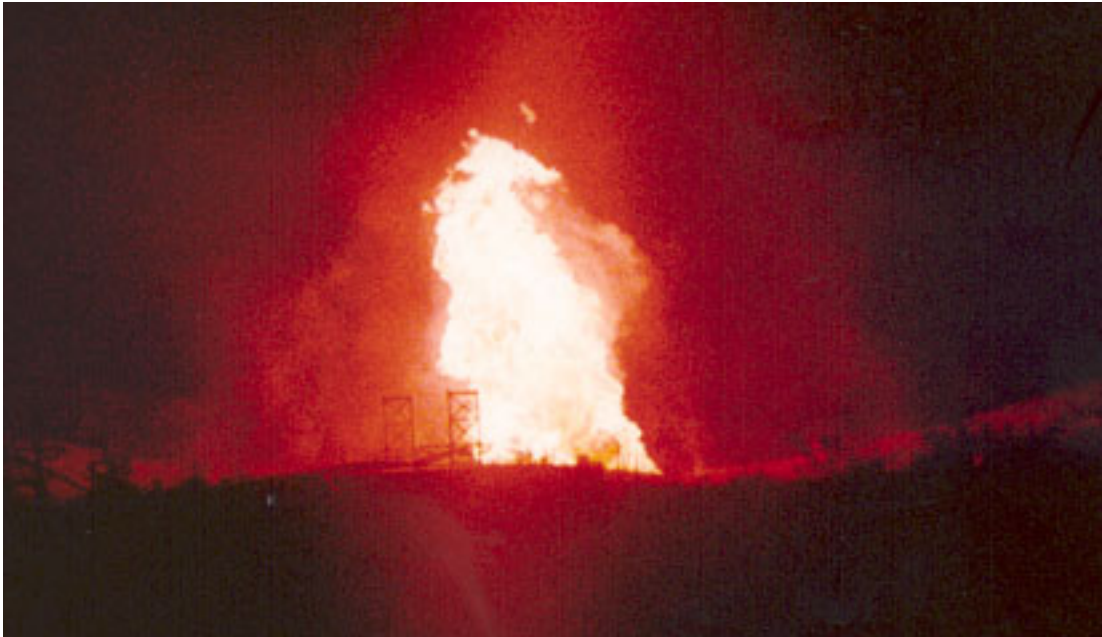
**Figure 5.** Post-rupture fire. At lower left of fireball can be seen the 85-foot-tall support structures for the pipeline suspension bridges.

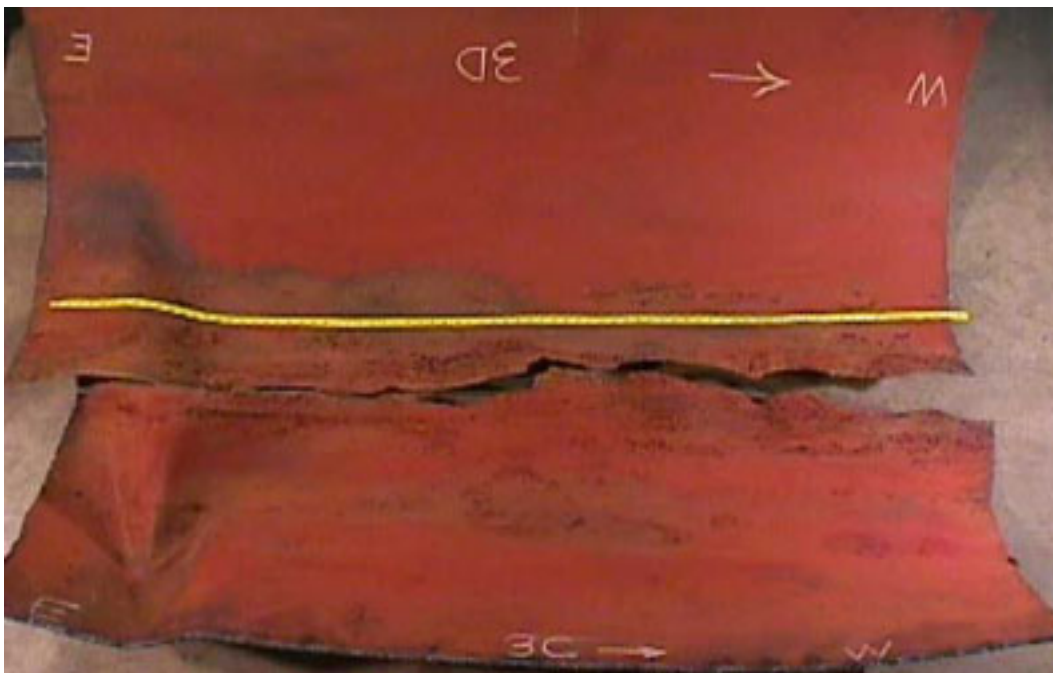
On-site examination of the three pieces of pipe that were ejected from the crater at the rupture site identified severe internal corrosion along the interior bottom of the pipe. (See figure 7.) From these three segments, eight pieces were excised and transported to the Safety Board's Materials Laboratory in Washington, D.C., for further examination. The examination of these pieces revealed no evidence of corrosion on the outside of the pipe or the internal surface across the top half of the pipe (between the 9 and 3 o'clock positions looking downstream/west). Severe wall loss due to corrosion was observed on the inside of the pipe at the bottom.

**Figure 7.** Fractured section of line 1103.

The area of corrosion damage extended 21 feet 5 inches. Sections of the girth (circumferential) and seam (longitudinal) welds that were in the bottom half of the pipe exhibited damage from internal corrosion similar to that found on the bottom pipe wall. The extent of corrosion damage (metal loss and number of pits) was most severe along the bottom of the pipe; the most severely corroded area reduced the original pipe wall thickness by 72 percent. (See figure 8.) The wall of many of the corrosion pits contained striations that extended around the pit. (See figure 9.) Within this length of corrosion damage were five circumferential wrinkles<sup>19</sup> in the pipe wall on the top of the pipe.

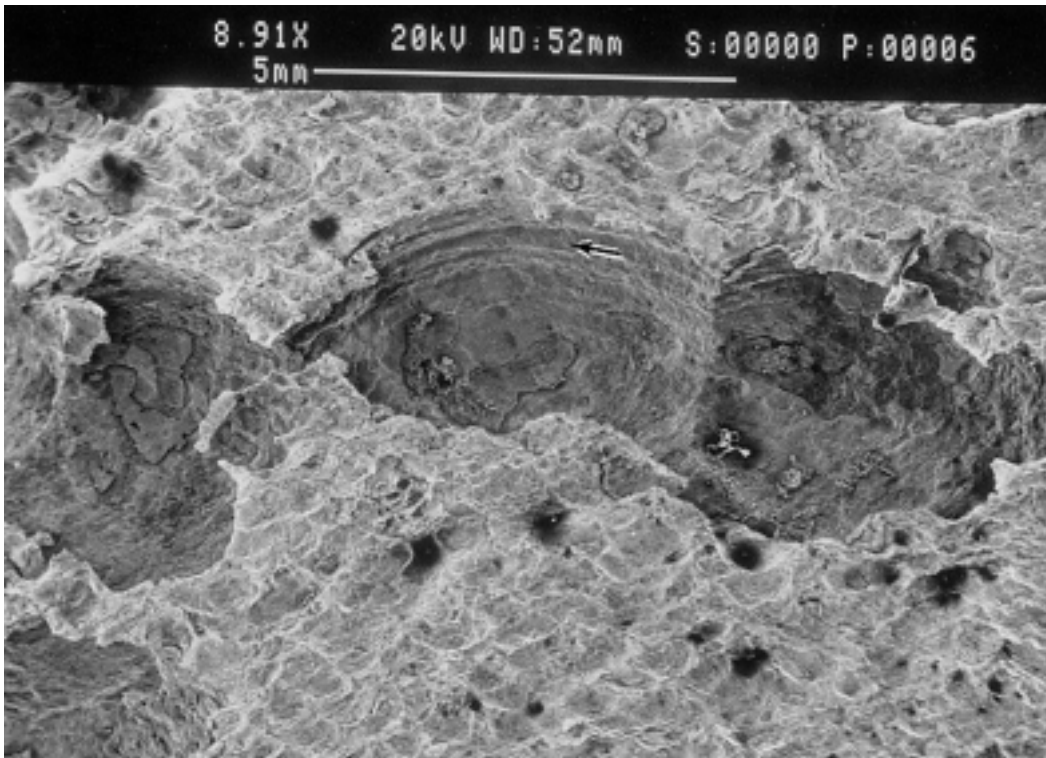
**Figure 9.** Microscopic view of corrosion pit showing striations

Examination of the fractures showed that a fracture face extended between the internal corrosion areas and the external wall of the pipe. The fracture faces resulted from overstress separation with no evidence of fatigue cracking or corrosion degradation, indicating that corrosion had not penetrated the wall of the pipe at the rupture point.
