NATIONAL TRANSPORTATION SAFETY BOARD

SPECIAL INVESTIGATION REPORT

**BRITTLE-LIKE CRACKING IN
PLASTIC PIPE FOR GAS SERVICE**

**Adopted: April 23, 1998
Notation 6984**

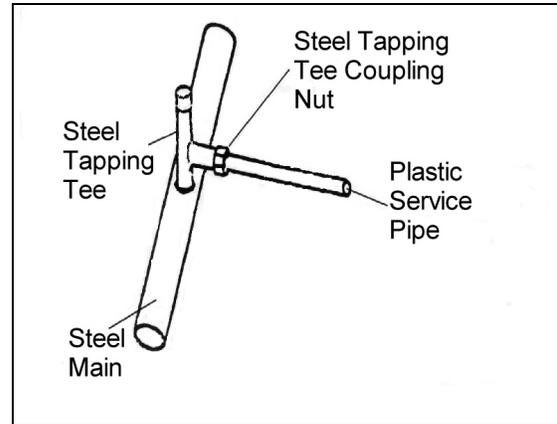
Excavations following the accident uncovered, at a depth of about 3 feet, a 4-inch steel main. Welded to the top of the main was a steel tapping tee manufactured by Continental Industries, Inc. (Continental). Connected to the steel tee was a 1/2-inch plastic service pipe. (See figure 2.) Markings on the plastic pipe indicated that it was a medium-density polyethylene material manufactured on June 11, 1970, in accordance with American Society for Testing and Materials (ASTM) standard D2513. The pipe had been marketed by Century Utility Products, Inc. (Century). The plastic pipe was found cracked at the end of the tee's internal stiffener and beyond the coupling nut.

The investigation determined that much of the top portion of the circumference of the pipe immediately outside the tee's internal stiffener displayed several brittle-like slow crack initiation and growth fracture sites. These slow crack fractures propagated on almost parallel planes slightly offset from each other through the wall of the pipe. As the slow cracks from different planes continued to grow and began to overlap one another, ductile tearing occurred between the planes. Substantial deformation was observed in part of the fracture; however, the initiating cracks were still classified as brittle-like.

Figure 2 -- Typical plastic service pipe connection to steel gas main. Many connections are protected against shear and bending forces by a plastic sleeve that encloses the service pipe-to-tee connection on either side of the coupling nut.

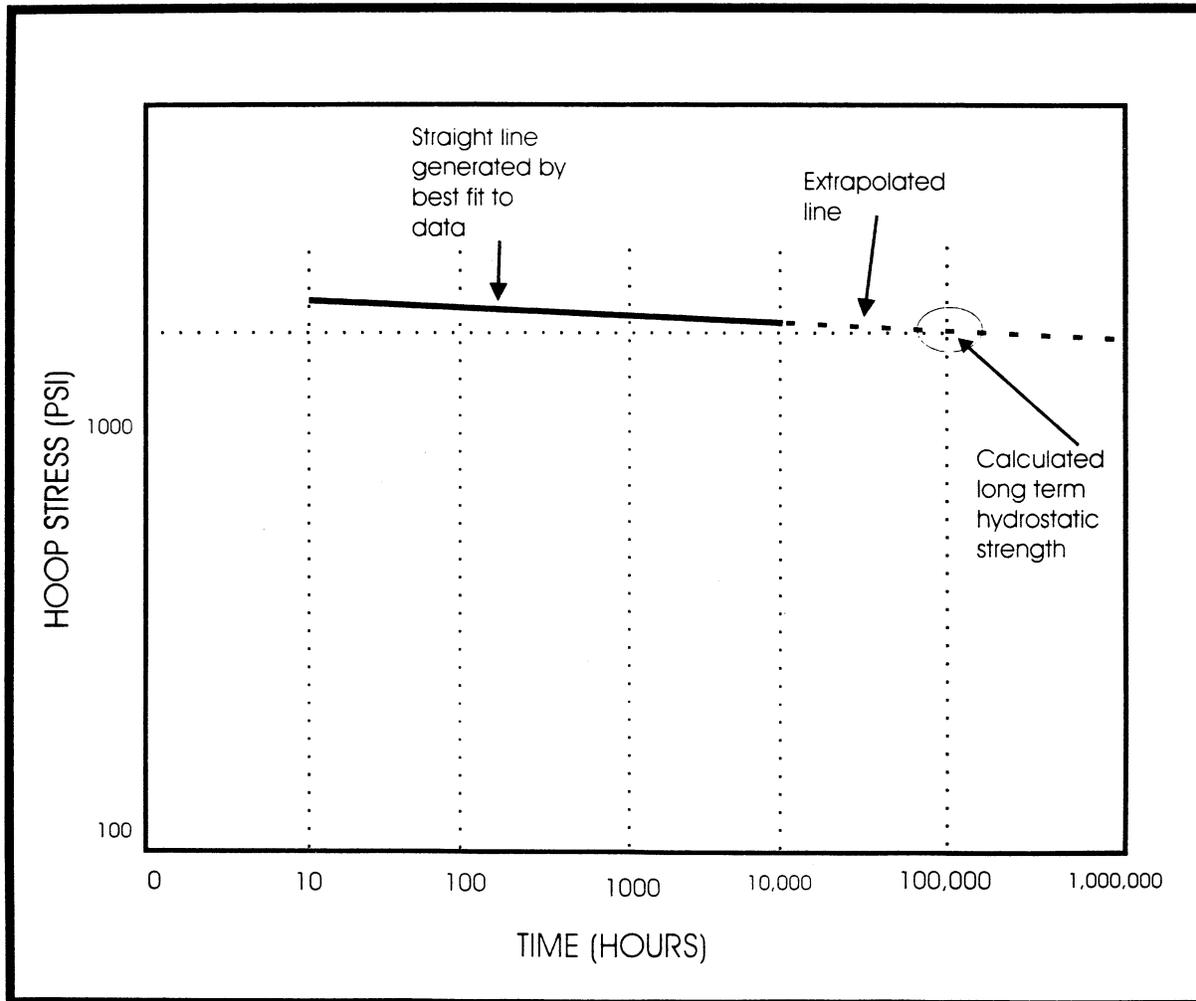
The testing process involves subjecting pipe samples to various hoop stress levels, and then recording the time to rupture. For some samples at some pressures, rupture will occur in as little as 10 hours. As hoop stress is reduced, the time-to-failure increases. At some hoop stress level, at least one of the tested specimens will not rupture until at least 10,000 hours (slightly more than 1 year). After the rupture data points (hoop stresses and times-to-failure) for this material have been recorded, the data points are plotted on log-log coordinates as the relationship between hoop stress and time-to-failure. (See figure 3.) A mathematically developed "best-fit"

Figure 3 -- Stress rupture data plotted as best-fit straight line and extrapolated to determine long-term hydrostatic strength. (Derived from A.G.A. *Plastic Pipe Manual for Gas Service*.)

During the 1960s and 1970s, some experts began to question the validity of the PPI procedure's assumption of a continuing, gradual straight-line decline in strength (figure 3).⁴⁷ By the late 1970s and early 1980s, the plastic piping industry in the United States realized that

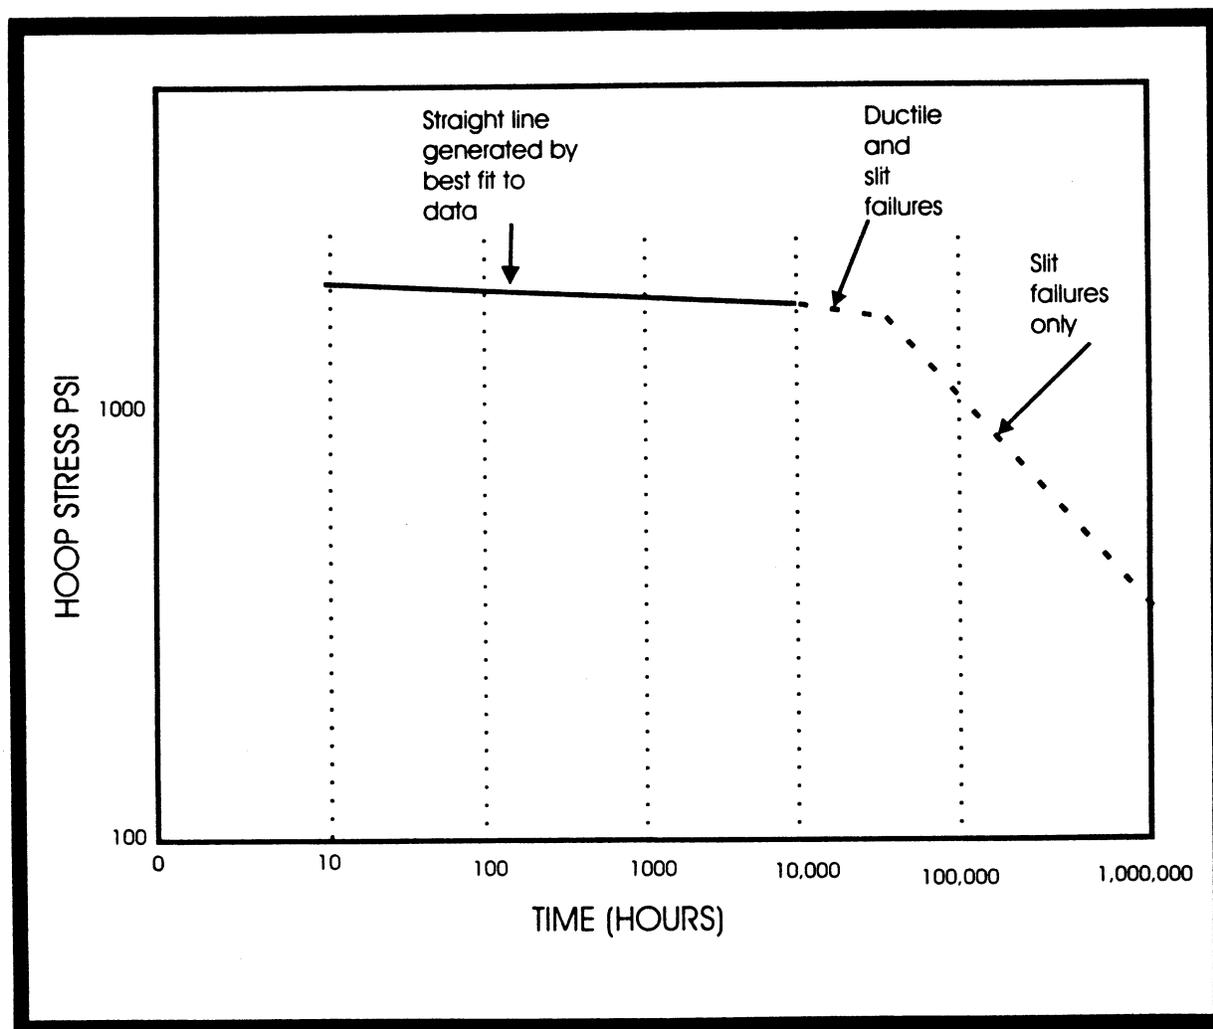
testing piping materials at elevated temperatures was a way to accelerate failure behavior that would occur much later at lower temperatures (such as 73 °F). Based on data derived from elevated-temperature testing, the industry concluded that the gradual straight-line decline in strength assumed by the PPI procedure was not valid. Instead, two distinct failure zones were indicated for polyethylene piping in stress rupture testing. (See figure 9.) The first zone is characterized by the gradual straight-line decline in strength accompanied primarily by ductile fractures. The first zone gradually transitions to the second zone, which is characterized by a more rapid decline in strength accompanied by brittle-like fractures only. The time and magnitude of this more rapid decline in strength varies by type and brand of polyethylene. Piping manufacturers have worked to improve their products' resistance to slit-type failures and thus to push this downturn further out in time. The PPI procedure did not account for this downturn, and the difference between the actual

falloff shown in figure 9 and the projected straight-line strengths shown in figure 3 for listed materials became more pronounced as the lines were extrapolated beyond 100,000 hours.

Figure 9 -- Stress rupture data plotted as best-fit straight line transitioning to downturn in strength. (Derived from *A.G.A. Plastic Pipe Manual for Gas Service*.)

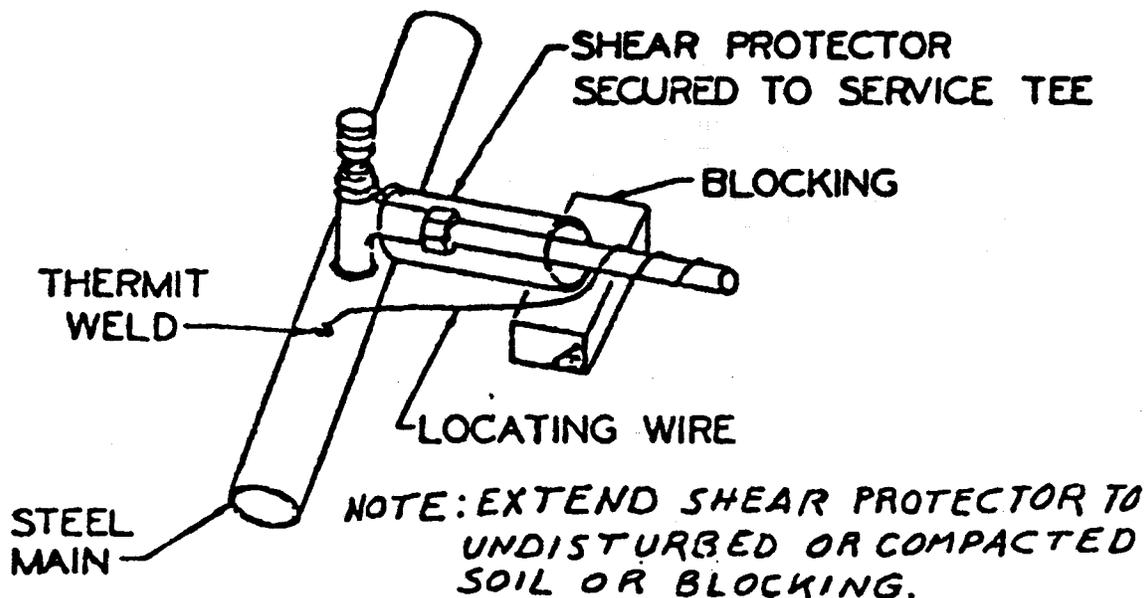
Figure 11 reproduces an illustration from *Book D-2*. This figure shows a steel tapping tee with a compression coupling joint connected to a plastic service. The illustration shows a protective sleeve and includes a note to extend the protective sleeve to undisturbed or compacted soil or to blocking. But the figure also shows the blocking positioned so that either the edge of the blocking or the edge of the protective sleeve might provide a fixed contact point on the plastic service pipe if the weight of backfill were to cause the pipe to bend down. Additional illustrations within this GEOP series book show this same positioning of the blocking with respect to the plastic pipe.

Figure 11 -- Reproduction from A.G.A. GEOP series illustrating application of protective sleeve. (Hand-scribed notation from the original.)
